Manhole Inspection Summary

Manhole # S45A__019MH

Location Address: **524 Chapel St.**

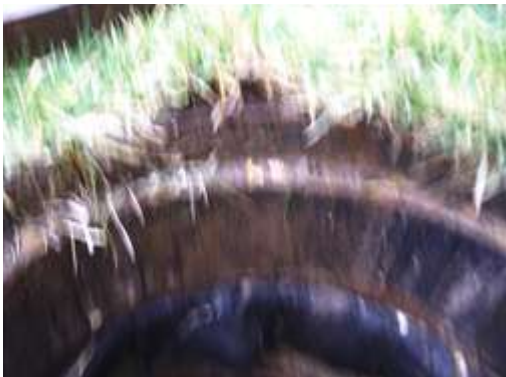
frame

Frame Offset: **0** (in.) Condition: ☐ Sound ☐ Cracked ☒ **Leaks**

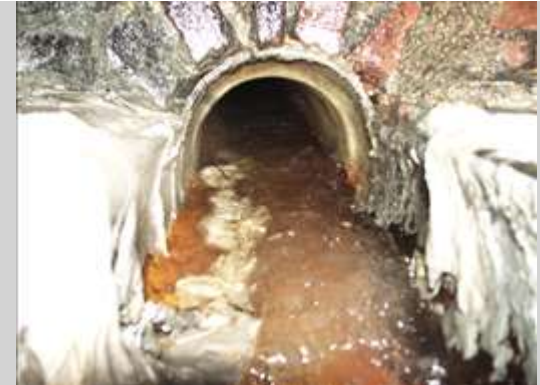
12 O'Clock Outflow

8 in. Circular Gravity Sewer
Pipe Out @ 12 O'Clock

Pipe Height: **12** (in.) Rod and Bar (Angled)
Pipe Material: **Clay** ☐ Pipe Lined
Invert Depth: **13.42** (ft.) Flow Characteristics: **Fast**
Deposits: ☒ None ☐ Mud ☐ Sludge ☐ Debris ☐ Grease
Silt Depth: (in.) Deposits Extent:
Infiltration: **None** Pipe Seal Cond: **Sound**

Drop: **None**

Connects To: **Manhole**

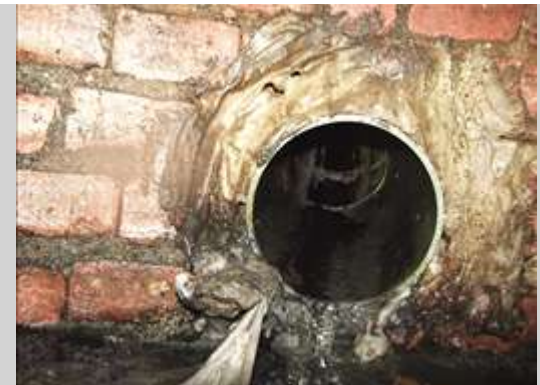
3 O'Clock Inflow

8 in. Circular Gravity Sewer
Pipe In @ 3 O'Clock

Pipe Height: **12** (in.) Rod and Bar (Angled)
Pipe Material: **PVC** ☐ Pipe Lined
Invert Depth: **10.83** (ft.) Flow Characteristics: **Fast**
Deposits: ☒ None ☐ Mud ☐ Sludge ☐ Debris ☐ Grease
Silt Depth: (in.) Deposits Extent:
Infiltration: **None** Pipe Seal Cond: **Sound**

Drop: **Outside** Rod and Bar
Angled: **Yes** Reading: **11.83** (ft.)
Inv Depth: **12.83** (ft.)

Drop Condition: **Open**

Connects To: **House connection / Service line**

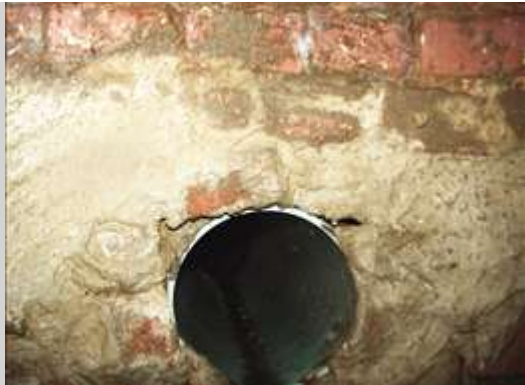
6 O'Clock Inflow

8 in. Circular Gravity Sewer

Pipe In @ 6 O'Clock

Pipe Height: **12** (in.) Rod and Bar (Angled)

Pipe Material: **Clay** ☐ Pipe Lined

Invert Depth: **13.42** (ft.) Flow Characteristics: **Fast**

Infiltration: **None** Pipe Seal Cond: **Sound**

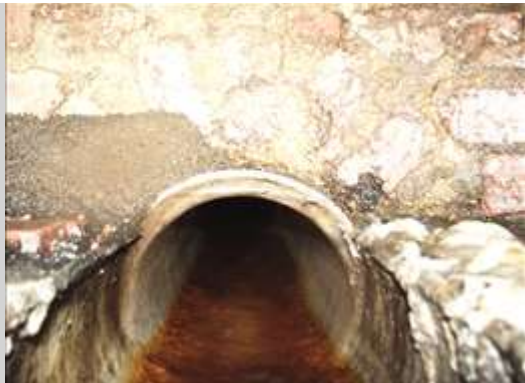
9 O'Clock Inflow

4 in. Circular Gravity Sewer

Pipe In @ 9 O'Clock

Pipe Height: **8.4** (in.) Rod and Bar (Angled)

Pipe Material: **PVC** ☐ Pipe Lined

Invert Depth: **4.83** (ft.) Flow Characteristics: **None**

Infiltration: **None** Pipe Seal Cond: **Sound**
